Sanitary District 1 – Cedar Lake

LAKE LEVEL HISTORY

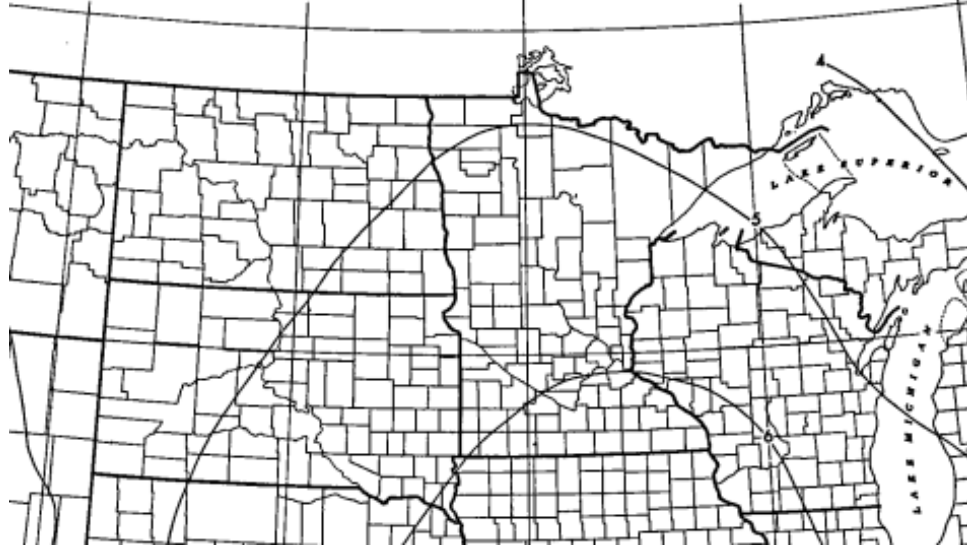
100-YEAR 24-HOUR RAINFALL (INCHES)

I looked at my Hydrology course book to see how often we statistically can expect a rain event like that. The Department of Commerce Technical Paper No. 40 Rainfall Frequency Atlas of the United States showed that the probability of only a 5.5-inch rainfall in our area should only occur once every 100 years. We had 6 or more inches. At the time of the rainfall, we already had 2 inches of water running out of the outlet culvert. Extreme events often require prompt and often dramatic response not appreciated by all to protect our resource.

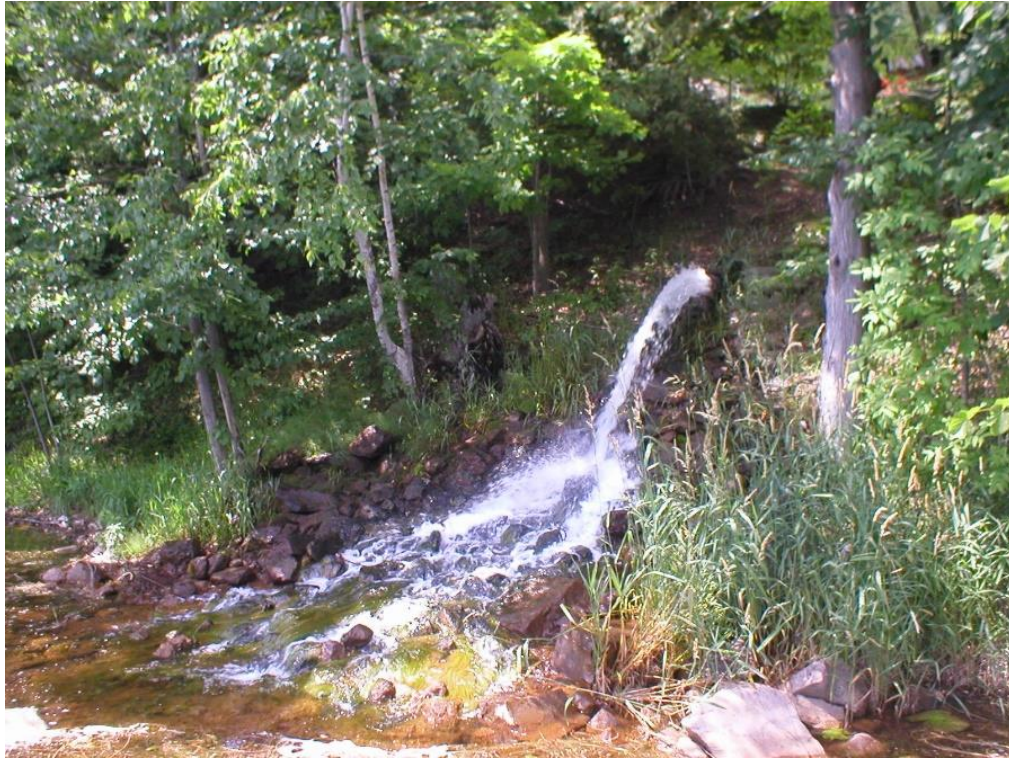
500 gallon per minute well installed in 1972

Variations in the lake level prompted the challenging permitting of one of a handful of wells in Wisconsin specifically for controlling those major lake fluctuations. In 1972, a well was drilled to a depth of 600 feet. A pump was installed to produce 500 gallons of water from the Niagara limestone formation often used for major cities water source.

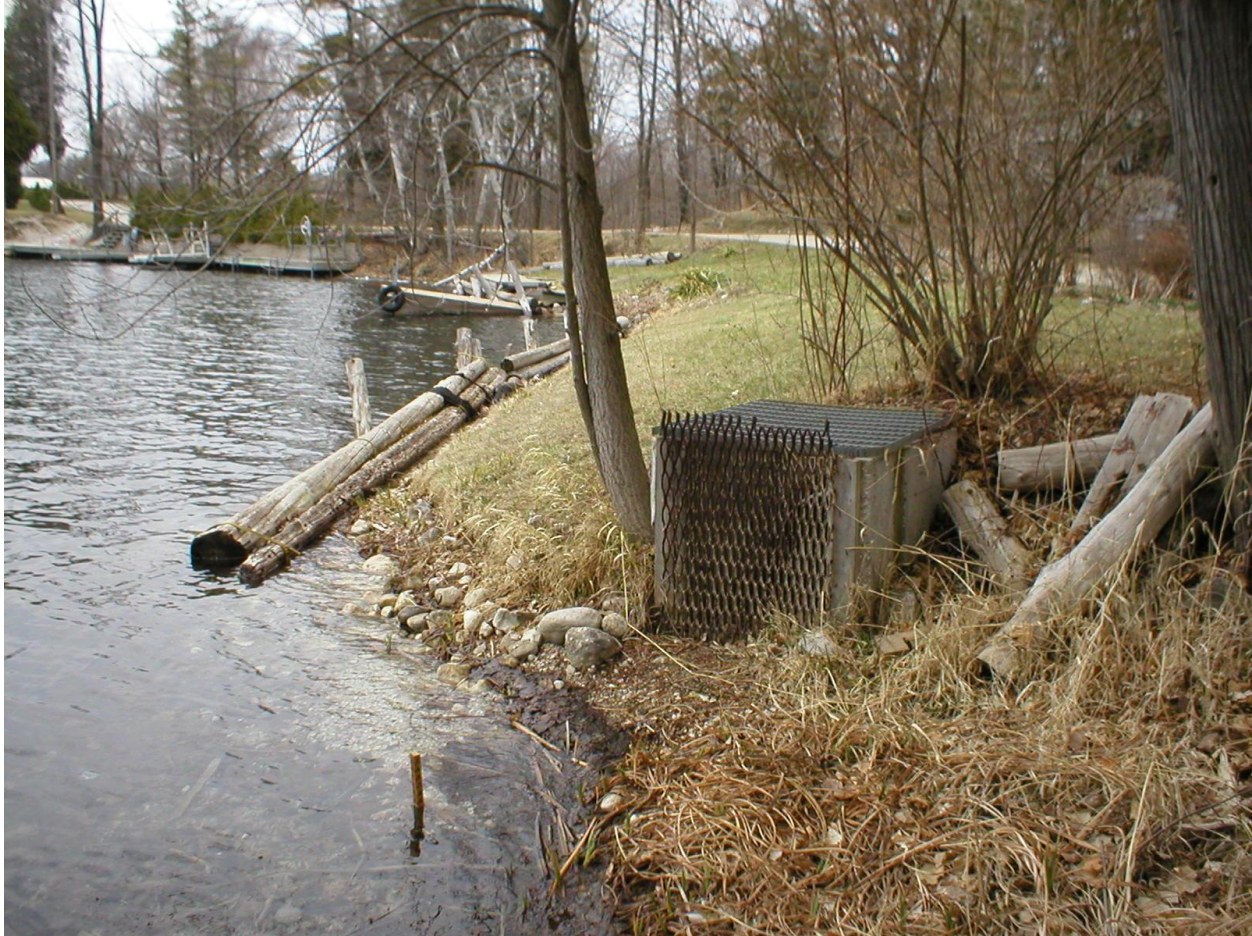
18-inch diameter culvert installed in 1986 (currently screened by cattails)

In 1986 a determination of an Ordinary High Water Mark (OHWM) was made by the WDNR and the permit was issued to construct the 18-inch diameter PVC culvert with its lowest point (invert) to match the OHWM.

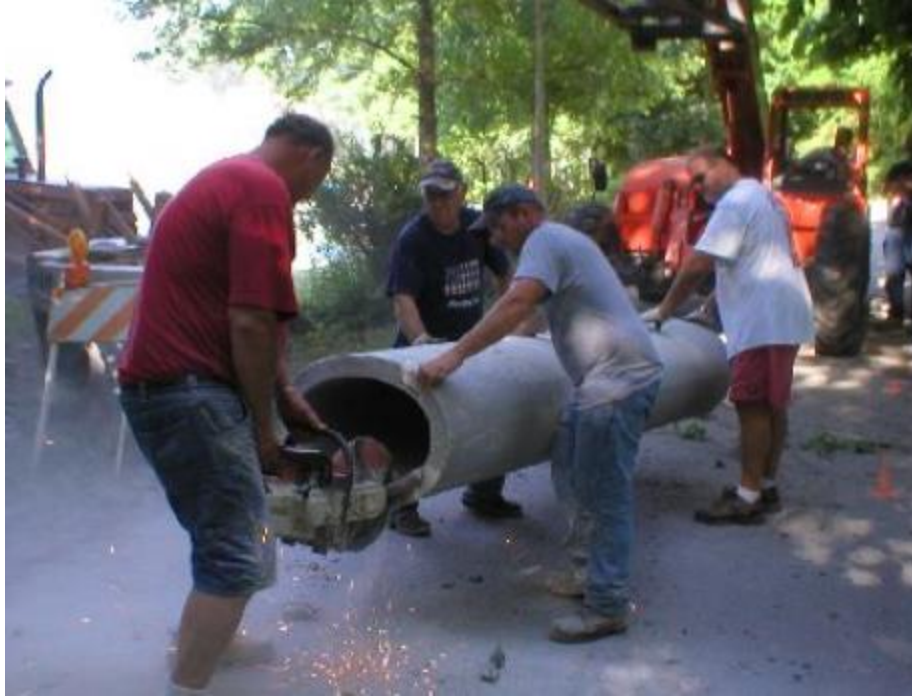
18-inch elliptical culvert installed in 2010

Prompt action was taken to permit and place a second culvert adjacent to the existing culvert to aid in quickly lowering the lake level should a similar event occur. A permit application was submitted to have the second culvert be 3.5 inches lower to allow for a 2x4 to be installed and removed should the lake need to be lowered quickly. Unfortunately, the WDNR ruled that the 2x4 would be considered to be a dam and an Army Corps of Engineer permit along with public hearings would be needed or we could place it at the same elevation as the first culvert. It was permitted to place it at the same elevation as the first culvert (invert or lowest point of the culvert and at the OHWM of the original culvert) and use an elliptical culvert that had a higher flow capacity.

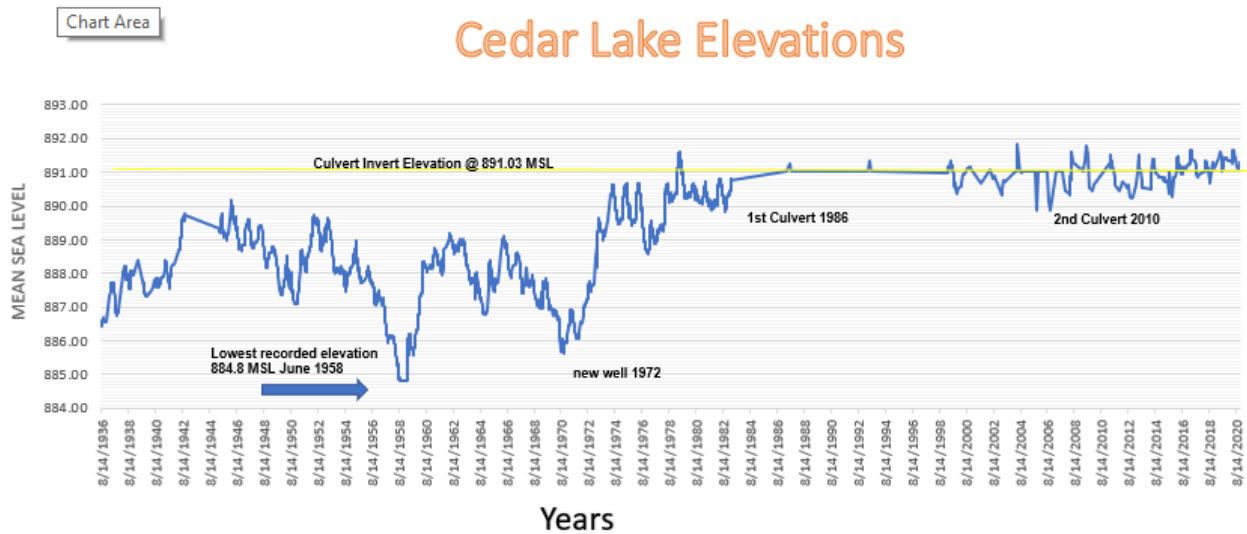
The following plot shows the fluctuations and the ability of the well and culverts to minimize the sever fluctuations.
